Technical Service Bulletin

NUMBER: 08-20-00

Horn Inoperative Or Sound Is Weak Or Muted

2000 (PL) Neon

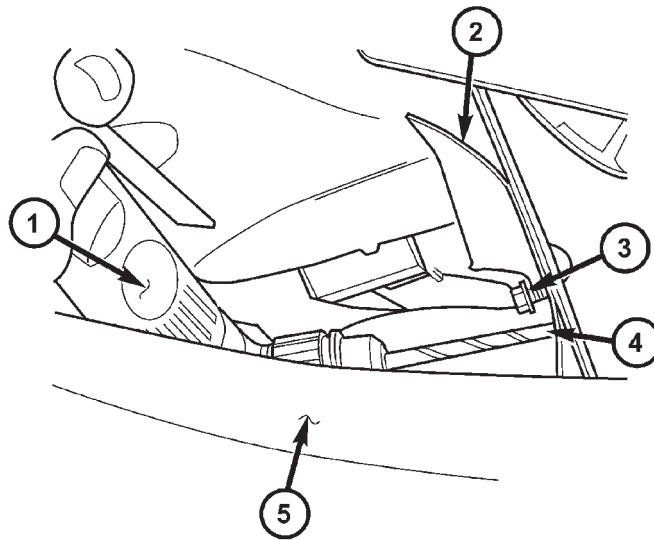
FIGURE 1

Due to horn orientation, water may enter the horn interior and cause damage. The horn may not work or the customer may report that the horn sounds quieter than before.

2. Remove the far right screw of the grill emblem where it attaches to the head lamp module housing.
3. Remove the two screws attaching the right headlamp module to the upper crossmember.
4. Pull the right headlamp module out and remove the connectors.
5. Remove the headlamp module from the vehicle.
6. Disconnect and remove the horn. Discard the horn.
7. Cut out the template provided in the kit.
8. Install the template and hold it in place by inserting the horn mounting bolt in its original position through the template. Mark the location of the new hole through the template.
9. Using a 6.5–mm (.25 in.) drill bit and an angle drill, drill a hole through the sheet metal at the point marked in step 8 (Figure 1).

10. Position and install the new horn using the original bolt hole. The new hole drilled in step 9 is for the anti–rotation tab on the new horn. The horn will now be approximately horizontal.
11. Install the headlamp module assembly and the grill emblem screw.
12. Install the battery negative cable.
