Technical Service Bulletin

NUMBER: 08-21-00

Antenna Mast Installation

2000 – 2001 (PL) Neon

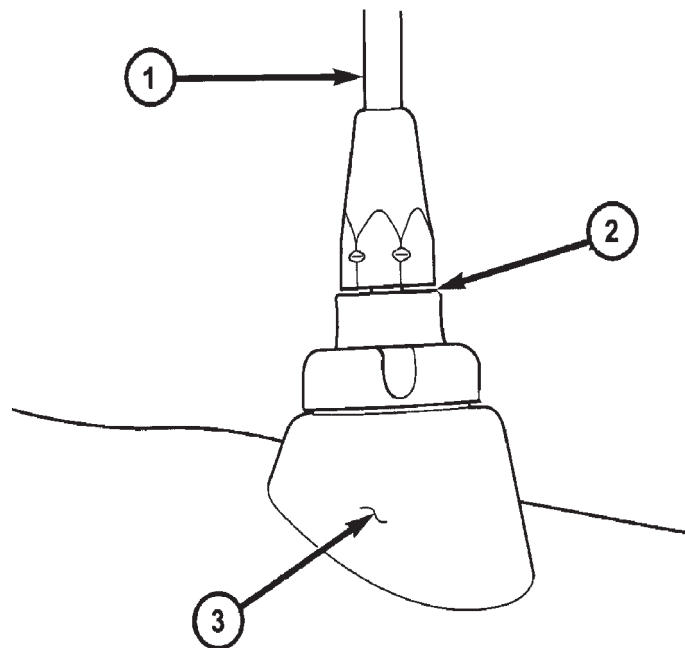
FIGURE 1

The Neon antenna mast is installed at the dealership during new vehicle preparation. Recently antenna masts have been coming into the material return center with mounting surfaces stripped. The Neon antenna should be torqued to 3.2 Nm (28 In. lbs.). With the antenna mast torqued to the proper amount (3.2 Nm (28 in. lbs)) there will be a slight gap between the mast and the base (Figure 1). The gap is there to ensure that there is no contact between the bottom of the antenna mast and the plastic surrounding the metal insert on the base. **Do not attempt to close the gap between the antenna mast and the base.**

1-	ANTENNA MAST
2-	GAP SHOULD EXIST HERE
3-	ANTENNA BASE
