# Technical Service Bulletin

**NUMBER:** 09-08-99

Multi-Layer Steel (MLS) Head Gasket Installation Procedures

**NOTE: THIS INFORMATION APPLIES TO MODELS WITH A 2.0L SOHC/DOHC (NATURALLY ASPIRATED) OR 2.4L ENGINE.**

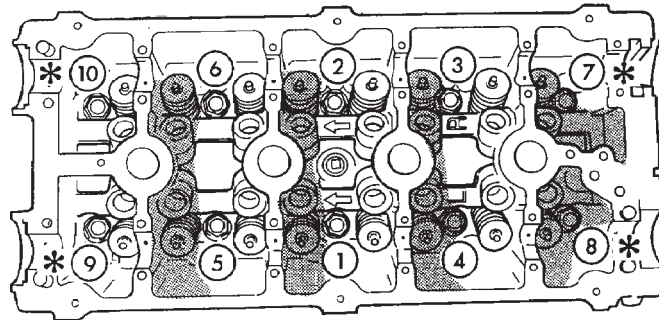
**FIGURE 1**

**NOTE: THE 4 SHORT BOLTS ARE PLACED IN THE CORNERS.**

1-	LOCATION OF 110mm (4.330 in.) BOLTS
----	-------------------------------------

- A. Torque all center bolts to 34 Nm (25 Ft Lbs), Torque the 4 corner bolts to 27 Nm (20 Ft Lbs) see Fig 1 for torque sequence.
- B. Torque all center bolts to 68 Nm (50 Ft Lbs), Torque the 4 corner bolts to 47 Nm (35 Ft Lbs) see Fig 1 for torque sequence.
- C. Re-torque all center bolts to 68 Nm (50 Ft Lbs), Re-torque the 4 corner bolts to 47 Nm (35 Ft Lbs) see Fig 1 for torque sequence.
- D. Tighten all bolts in the specified sequence (Fig 1) an additional 90° (1/4 turn).
