# Technical Service Bulletin

**NUMBER:** 19-02-00 Rev. A

Ignition Lock Cylinder Service

2001	(PT)	PT Cruiser
2000 – <b>**2001**</b>	(PL)	Neon
2000	(JA)	Cirrus/Stratus
<b>**2001</b>	(JR)	Stratus Sedan/Sebring Sedan/Sebring Convertible <b>**</b>
2000	(JX)	Sebring Convertible
2000 – <b>**2001**</b>	(XJ)	Cherokee
2000 – <b>**2001**</b>	(TJ)	Wrangler

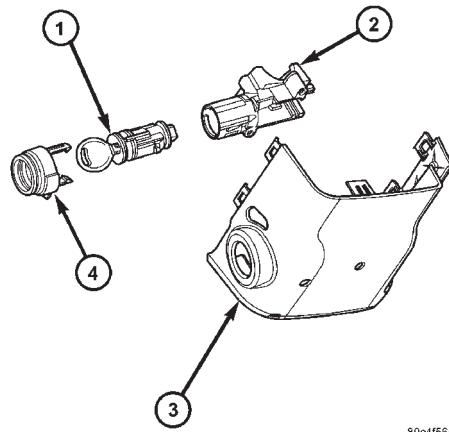
**FIGURE 1**

Recent changes to the ignition lock cylinder have resulted in the removal of a chamfer on the lock cylinder retaining pin. This may cause the pin to hang up on the plastic trim ring when the lock cylinder is removed. If this situation is encountered on any of the models listed above, it may be necessary to remove the trim ring prior to removing the lock cylinder. This is done by unseating the retaining tabs on the trim ring and removing it. The lock cylinder can then be removed without any interference (See Figure 1). Future models will modify the lock housing to eliminate this condition.
