# Technical Service Bulletin

**NUMBER:** 19-02-99 Rev. A

Clunking Or Rattle In Steering Wheel/Steering Column

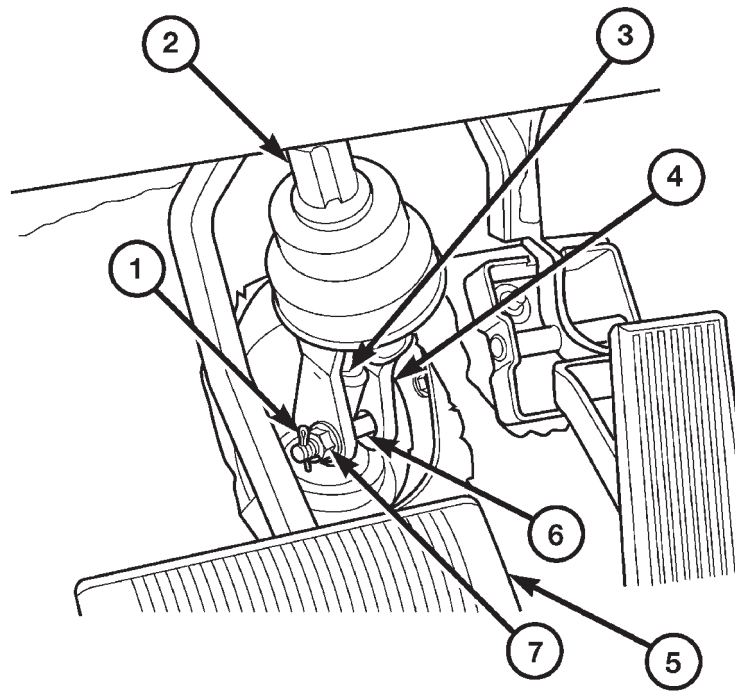
**FIGURE 1**

Steering wheel/column clunking or rattle is more frequent while hitting bumps or on hard turns.

3. Detach the lower steering column intermediate shaft from the steering gear shaft (Figure 1) This allows the steering column preload to reset.
4. Re-attach the intermediate shaft to the steering gear using a new pinch bolt from the Parts Required section of this bulletin. Tighten the bolt to 27 N·m (240 in. lbs.).
5. Install the retaining clip/pin into the pinch bolt (Figure 1).

**NOTE: A NEW STEERING GEAR COUPLING PINCH BOLT MUST BE USED WHEN RE-ATTACHING THE INTERMEDIATE SHAFT TO THE STEERING GEAR. THIS BOLT HAS A LOCKING PATCH THAT IS DESTROYED WHEN THE NUT IS REMOVED.**
