Technical Service Bulletin

NUMBER: 23-06-00

****Water Leak From Top Edge Of Right Or Left Front Door****

2000 (PL) Neon

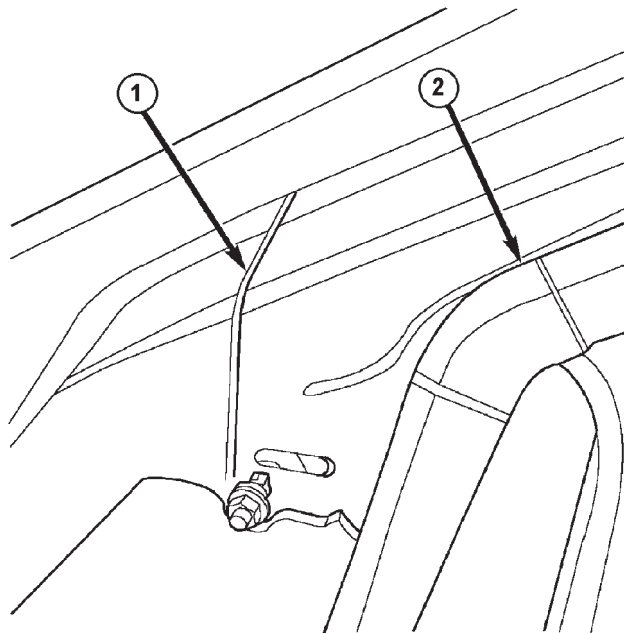
FIGURE 1

****Water leaks from the top edge of the right and/or left front door into the passenger compartment. ** This leak is due to a step in the sheet metal laser welded joint seam (Figure 1) .**

INTERIOR TOP LEFT CORNER OF RIGHT FRONT DOOR SHOWN

2 - SHEET METAL LASER WELDED JOINT SEAM

Inspect the right and left front door frame at the top laser welded joint seam. If one side of the joint is raised above the other, perform the Repair Procedure (Figure 1).

1. **Open the front door(s). Measure the top laser welded joint seam on each door, if the step is less than 1mm (0.039 in), perform Repair Procedure 1. If the step is more than 1mm (0.039 in) perform the Repair Procedure 2. **

1. Remove the door trim panel.
2. Clean the step area with isopropyl alcohol (Figure 1).
3. Tape off the area around the step leaving a 1/4 inch space around the seam step (Figure 2).

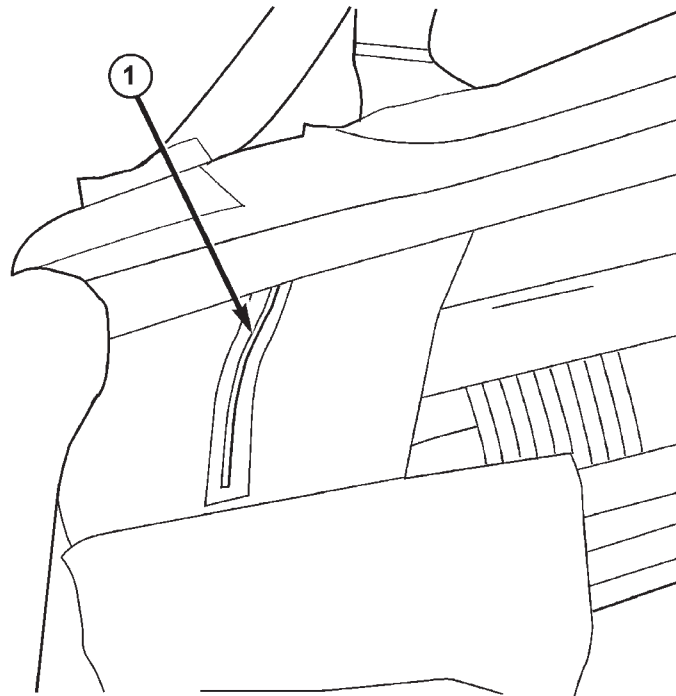
FIGURE 2

1 - 1/4 IN. GAP AROUND SEAM CREATED BY MASKING TAPE

4. Squeeze out a quarter size portion of the Sure Check Clear Sealer or equivalent onto a plastic pallet. Use a plastic spreader such as one used for applying body fillers, to spread the sealer across the taped off area. Ensure that the sealer is applied even and smooth.
5. Remove the tape, by pulling it away from the sealed area at right angles. This will prevent damage to the sealer edges.
6. Allow the sealer to cure for 45 minutes before closing the door.
7. Shut the door and water test the area. If the leak is still present, repeat steps 2 through 6 to add an additional layer of sealer onto the seam.
