Technical Service Bulletin

NUMBER: 23-16-99

Decklid Does Not Open With First Cycle Of Key Fob Operation

2000 (PL) Neon

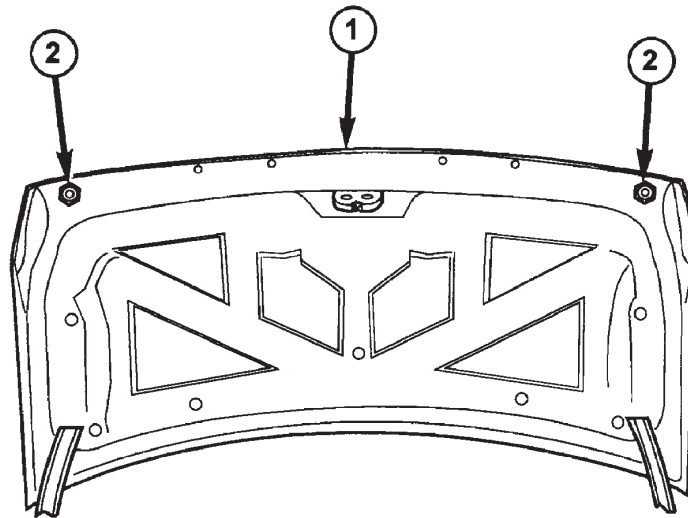
FIGURE 1

The decklid does not open after one cycle of the key fob (two button pushes), but does open after 2 or 3 cycles of the key fob button. This is possibly due to incorrect adjustment of the decklid over slam bumpers not an electrical problem with the key fob system. If the deck lid over slam bumpers are adjusted too far outward, the load on the striker prevents the latch from opening after only one cycle of the key fob.

1. Open the decklid, mark each bumper and turn each overslam bumper 1/4 turn clockwise (Figure 1 & 2).
2. Close the decklid and cycle the key fob decklid button.
3. Repeat the overslam adjustment procedure (steps 1 & 2) until one cycle of the key fob opens the decklid.

NOTE: THE OVER SLAM BUMPERS SHOULD NOT PROTRUDE MORE THAN 20MM FROM THE DECKLID INNER SHEET METAL.
