Technical Service Bulletin

Number: 23-23-99

Rear Door Glass Will Not Roll Down All The Way

2000 (PL) Neon

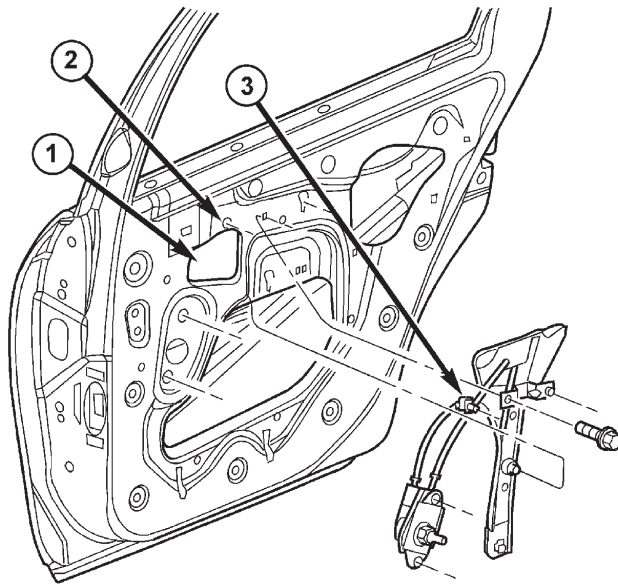
FIGURE 1

1-	Access Hole
2-	Conduit Cable Clip Attaching Hole
3-	Conduit Cable Clip

1. Remove the rear door trim panel and partial watershield to access the conduit clip using the procedure in the 2000 Neon Service Manual (publication No. 81-270-0025) 23-40.
2. Roll the rear door side window to the full up position.
3. Remove the conduit clip from the regulator conduit and discard (Figure 1).

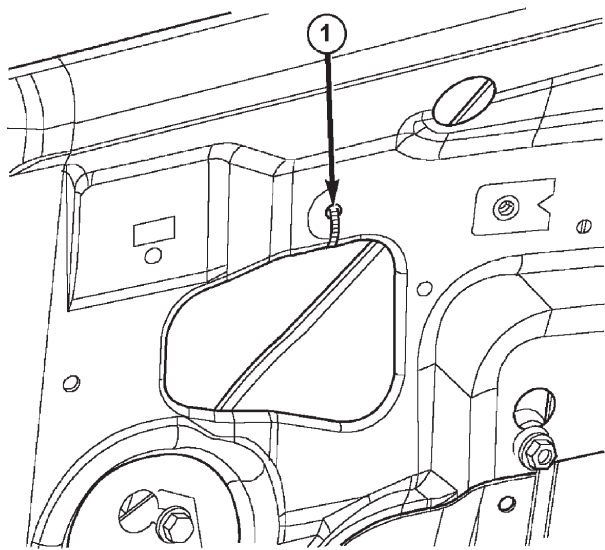
FIGURE 2

1-	Plastic Tie Strap
----	-------------------

- 4. Route plastic tie strap through conduit attaching hole, around conduit and back through access hole to securely fasten conduit to door inner panel (Figures 2 & 3).
