Technical Service Bulletin

Number: 23-23-99

Rear Door Glass Will Not Roll Down All The Way

2000 (PL) Neon

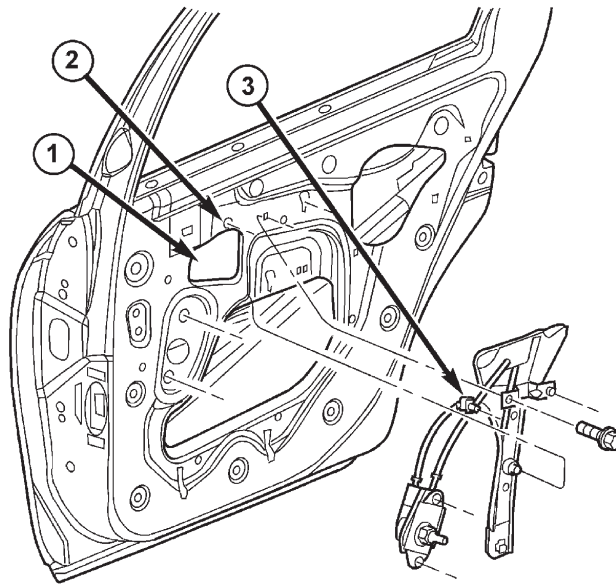
FIGURE 1

1-	Access Hole
2-	Conduit Cable Clip Attaching Hole
3-	Conduit Cable Clip

1. Remove the rear door trim panel and partial watershield to access the conduit clip using the procedure in the 2000 Neon Service Manual (publication No. 81-270-0025) 23-40.
2. Roll the rear door side window to the full up position.
3. Remove the conduit clip from the regulator conduit and discard (Figure 1).

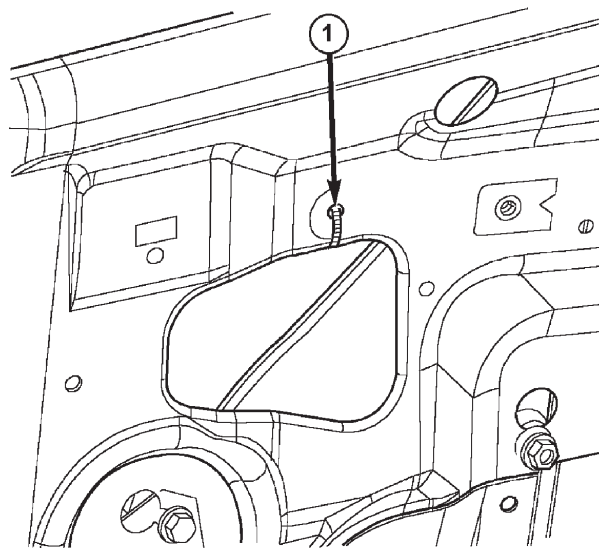
FIGURE 2

1-	Plastic Tie Strap
----	-------------------

- 4. Route plastic tie strap through conduit attaching hole, around conduit and back through access hole to securely fasten conduit to door inner panel (Figures 2 & 3).

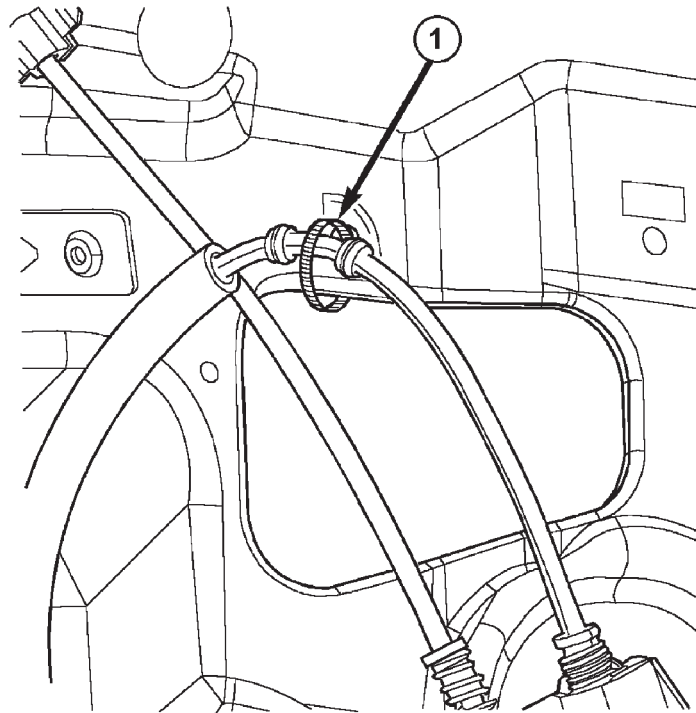
FIGURE 3

1-	Plastic Tie Strap
----	-------------------
