Technical Service Bulletin

NUMBER: 23-50-99

Instrument Panel Creak

2000 (PL) Neon

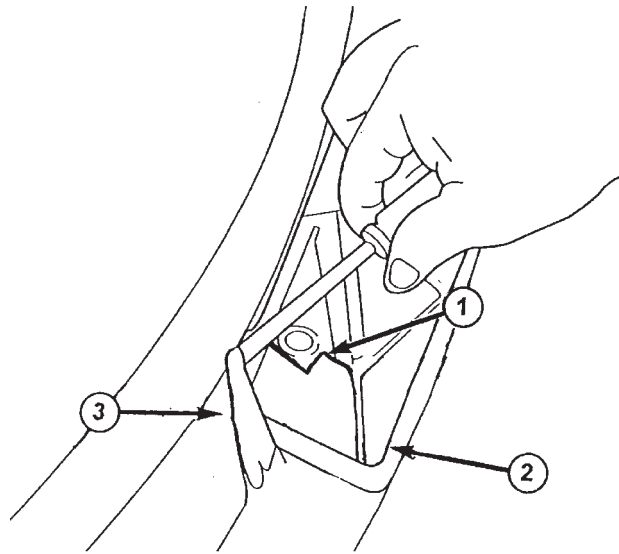
FIGURE 1

A creaking noise occurs while the vehicle is driven through sudden/quick turns or over bumps. The noise appears to originate from the right hand side of the instrument panel area. The noise is created by metal to metal contact of the cowl reinforcement panel and cowl top panel.

1-	AREA TO BE BENT APART SHOWN REFLECTED IN MIRROR
2-	MIRROR PLACED IN COWL AREA TO SHOW CONTACT AREA
3-	COWL TOP

1. Remove the windshield wiper arms following the procedure in the 2000 Neon Service Manual (Publication No. 81-270-0025) page 8K-5.
2. Remove the cowl screen cover following the procedure in the 2000 Neon Service Manual (Publication No. 81-270-0025) page 23-27.
3. Using Figure 1 as a reference, locate the area of the cowl reinforcement panel to be modified. Remove the excess sealer to allow access as needed. A mirror positioned to show the underside of the cowl top will help in locating the contact areas.
4. Use a screwdriver and bend the top of the cowl reinforcement panel down and away from the cowl top panel. A minimum clearance of 2.0 mm (.078 inch) should be obtained between the two panels (Figure 2).

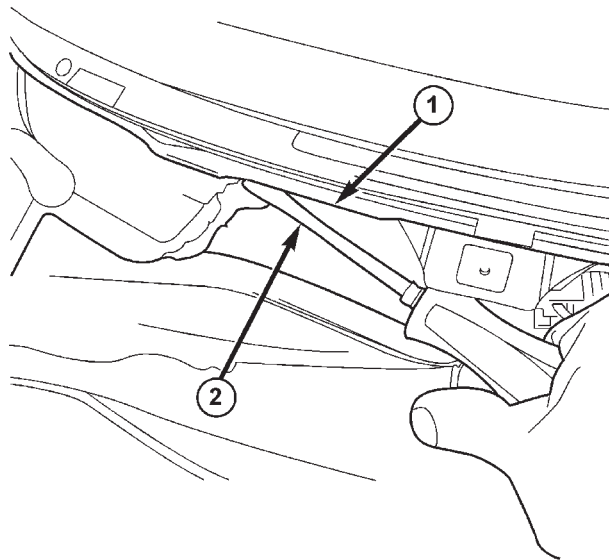
FIGURE 2

1-	COWL TOP PANEL
2-	SCREWDRIVER SHOWN IN POSITION TO CREATE CLEARANCE

5. Use Mopar Body Sealer (p/n 04318026) or equivalent to fill in the space created between the cowl reinforcement panel and the cowl top panel and in the area where the sealer was removed to gain access to the panels.
