Technical Service Bulletin

NUMBER: 24-17-99

Vibration Or Noise From HVAC Blower Motor

2000 (PL) Neon

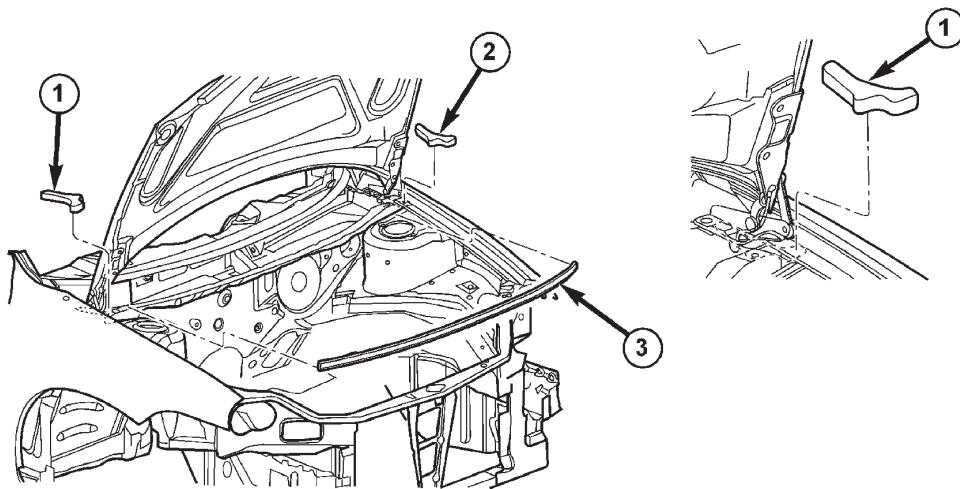
FIGURE 1

1-	FENDER TO HOOD HINGE SEAL
2-	FENDER TO HOOD HINGE SEAL
3-	COWL PLENUM TO HOOD WEATHERSTRIP

1. Remove the HVAC blower motor following the procedure in the 2000 Neon Service Manual (Publication No. 81-270-0025) beginning on page 24-21.
2. Remove any debris which is found in the HVAC blower motor.
3. Remove both wiper arm assemblies following the procedure in the 2000 Neon Service Manual (Publication No. 81-270-0025) beginning on page 8K-5.
4. Remove the cowl plenum to hood weatherstrip (Figure 1).
5. Remove the left and right fender to hood hinge seals (Figure 1).
6. Remove the cowl top screen assembly following the procedure in the 2000 Neon Service Manual (Publication No. 81-270-0025) beginning on page 23-27.
7. Remove any debris found in the cowl plenum.
8. Install the HVAC blower motor following the procedure in the 2000 Neon Service Manual (Publication No. 81-270-0025) beginning on page 24-21.
9. Operate the HVAC blower motor to verify that all debris has been removed.

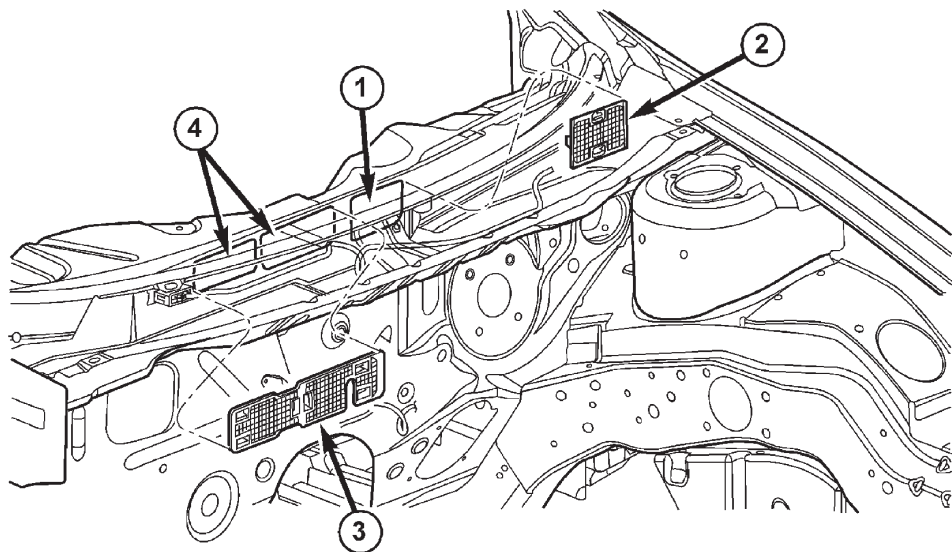
FIGURE 2

1-	LEFT COWL PLENUM OPENING
2-	LEFT COWL PLENUM SCREEN
3-	RIGHT COWL PLENUM SCREEN
4-	RIGHT COWL PLENUM OPENING

- 10. Install the new cowl plenum screens into the holes in the cowl plenum reinforcement as shown in Figure 2.
- 11. Install the cowl top screen assembly.
- 12. Install the new fender to hood hinge seals.
- 13. Install the cowl plenum to hood weatherstrip.
- 14. Install the wiper arm assemblies.
