# Technical Service Bulletin

**NUMBER:** 19-02-00 Rev. A

Ignition Lock Cylinder Service

2001	(PT)	PT Cruiser
2000 - <b>**2001**</b>	(PL)	Neon
2000	(JA)	Cirrus/Stratus
<b>**2001</b>	(JR)	Stratus Sedan/Sebring Sedan/Sebring Convertible <b>**</b>
2000	(JX)	Sebring Convertible
2000 - <b>**2001**</b>	(XJ)	Cherokee
2000 - <b>**2001**</b>	(TJ)	Wrangler

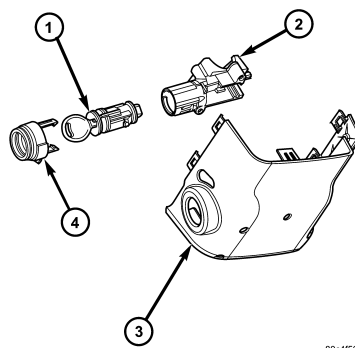
**FIGURE 1**

Recent changes to the ignition lock cylinder have resulted in the removal of a chamfer on the lock cylinder retaining pin. This may cause the pin to hang up on the plastic trim ring when the lock cylinder is removed. If this situation is encountered on any of the models listed above, it may be necessary to remove the trim ring prior to removing the lock cylinder. This is done by unseating the retaining tabs on the trim ring and removing it. The lock cylinder can then be removed without any Interference (See Figure 1). Future models will modify the lock housing to eliminate this condition.
