NUMBER: 23-026-01

GROUP: Body

Rear Window Will Not Go All The Way Down

2001 (PL) Neon

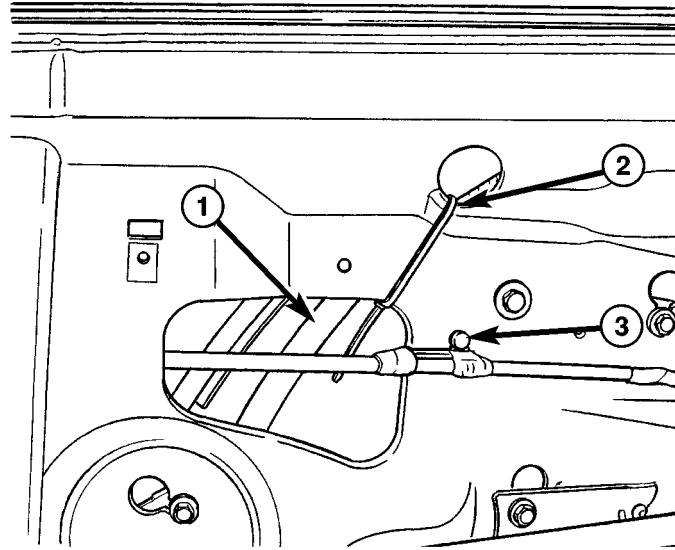
Fig. 1 TIE STRAP DOOR REGULATOR CABLE

One or both of the rear windows will not go down all the way. May feel like they are binding.

1. Remove the rear door trim panel as describe on page 23-79 of the 2001 Neon Service Manual (Publication No. 81-270-1025).
2. Carefully peel away the top part of the watershield to gain access to the regulator cables.
3. Install the tie strap around the outboard regulator cable and door inner sheet metal as shown (Fig. 1). Cut off the excess tie strap material.

- 4. Install the watershield and door trim panel.
- 5. Repeat procedure on other rear door.
