# Technical Service Bulletin

**NUMBER:** 23-044-00

Seat Back Rattle

2001 (PL) Neon

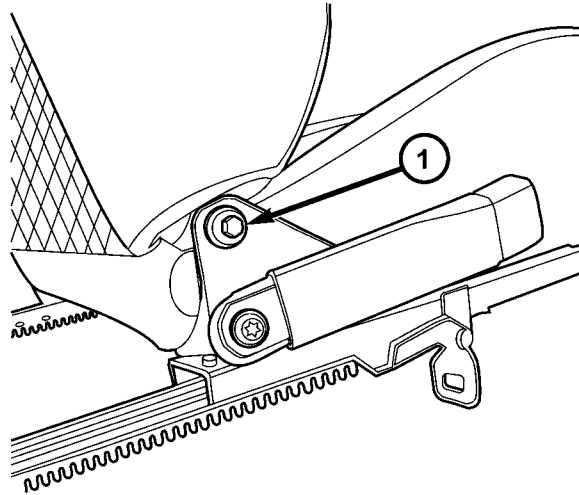
**Fig. 1 SEAT BACK PIVOT BOLT**

The front seat back may rattle due to extra shoulder length on the seat back pivot bolt.

1. Using the procedures provided under the Service Information tab of MDS2, or the information on page 23 – 107 of the 2001 Neon Service Manual (Publication No. 81-270-1025), remove either of the front seats.
2. Remove the seat back pivot bolt (using a 10 mm socket/wrench) (Fig. 1).
