NUMBER: 24-008-01

Poor A/C Performance/Expansion Valve Noise

2001 (PL) Neon
2001 (P2) Neon (International Markets)

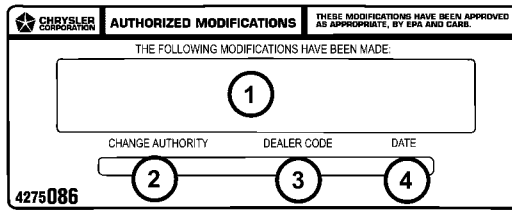
Fig. 2 AUTHORIZED MODIFICATION LABEL

1 - POWERTRAIN CONTROL MODULE P/N (INSERT P/N) USED AND INSERT STATEMENT "REVISED A/C REFRIGERANT LEVEL 765 GRAMS (27 OZ. OR 1.69 LBS.)"

3. Type the necessary information on the “authorized Software Update Label” p/n 04669020 (Fig. 1). Attach the label to the PCM and cover the label with the clear plastic overlay. Type the necessary information on the “Authorized Modification Label” p/n 04275086 (Fig. 2) and attach the label near the VECI label.
