Exhaust Tip Alignment

This bulletin involves adjusting the position of the intermediate and "Y" exhaust pipes.

2003 - 2004 (PL) Neon SRT4

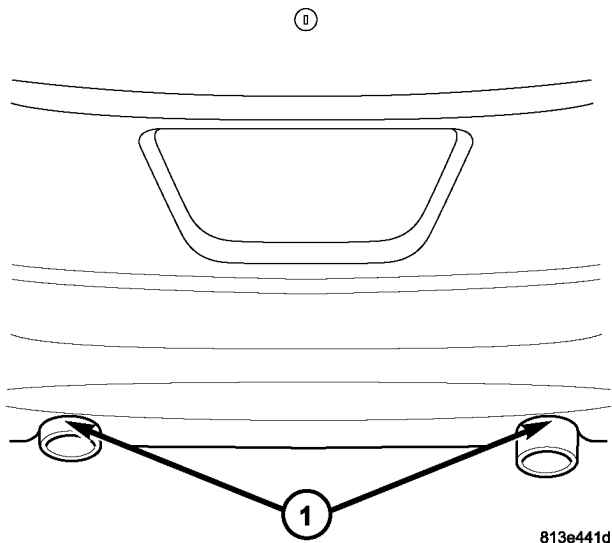
**Fig. 1 EXHAUST TIP MISALIGNMENT**

Dual exhaust tips are not in equal fore/aft alignment.

Visually inspect vehicle for exhaust tip alignment issues. If exhaust tips are misaligned in the fore/aft dimension relative to each other as shown in (Fig. 1), perform the Repair Procedure.

1 - RIGHT SIDE SHOWN PROTUDING MORE THAN LEFT SIDE - SHOULD BE EQUAL

1. Loosen intermediate exhaust pipe to catalytic converter clamp.
2. Loosen Y-pipe to exhaust intermediate pipe clamp.

**NOTE: It is critical that these clamps be loosened to the point where they are no longer providing any clamp load. The loosened components must have complete freedom of rotation. If this is not the case the setting process that follows will be ineffective.**

3. Raise the intermediate pipe to the point where the first bend from the catalytic converter has a clearance of 15-25 mm (5/8 in. - 1 in.) from the underbody.
4. With the intermediate exhaust pipe held in this position, tighten the intermediate pipe to converter clamp to a torque 52 Nm (38 ft. lbs.).

**NOTE: After the intermediate pipe to catalytic converter clamp has been tightened, the intermediate pipe to underbody clearance at the first bend must fall within the 15-25 mm (5/8 in. - 1 in.) specification. This clearance measurement to the underbody should be taken at the point where the intermediate pipe transitions from a fore/aft orientation to a cross car orientation.**

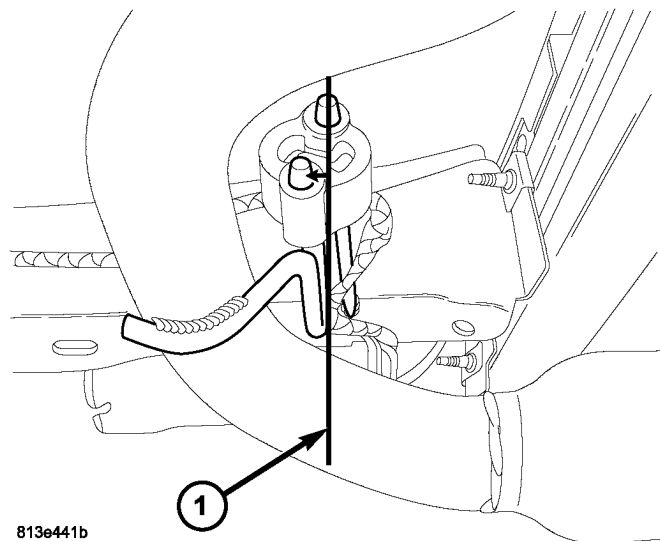
***Fig. 2 RIGHT SIDE ISOLATOR ROTATIONAL ORIENTATION AT GREATER THAN 6 O'CLOCK POSITION***

1 - EXHAUST TIP LOWER ISOLATOR HOLE/PIN PAST THE 6 O'CLOCK POSITION

5. Force the rearmost positioned exhaust tip forward so the rotational orientation of the exhaust tip isolator is greater than the 6 o'clock position, (Fig. 2).

6. With the rearmost exhaust tip held in this forward position, secure the Y-pipe to intermediate exhaust pipe clamp to a torque of 61 Nm (45 ft. lbs.).

**NOTE: When finished exhaust tip isolators should have a rotational orientation which has the lower hole/pin is closer to the front of the vehicle than the top hole/pin. For an optimal fit condition, the right and left exhaust tip isolator should have a equal rotational orientation.**
