Exhaust Tip Alignment

This bulletin involves adjusting the position of the intermediate and "Y" exhaust pipes.

2003 - 2004 (PL) Neon SRT4

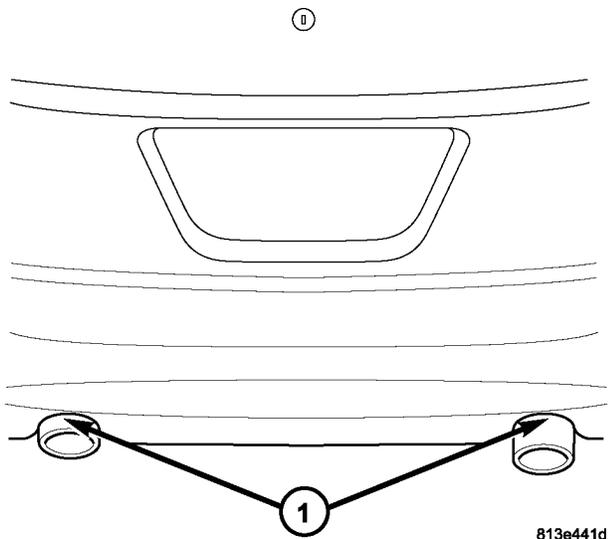
Fig. 1 EXHAUST TIP MISALIGNMENT

Dual exhaust tips are not in equal fore/aft alignment.

1 - RIGHT SIDE SHOWN PROTUDING MORE THAN LEFT SIDE - SHOULD BE EQUAL

1. Loosen intermediate exhaust pipe to catalytic converter clamp.
2. Loosen Y-pipe to exhaust intermediate pipe clamp.

NOTE: It is critical that these clamps be loosened to the point where they are no longer providing any clamp load. The loosened components must have complete freedom of rotation. If this is not the case the setting process that follows will be ineffective.

3. Raise the intermediate pipe to the point where the first bend from the catalytic convertor has a clearance of 15-25 mm (5/8 in. - 1 in.) from the underbody.
4. With the intermediate exhaust pipe held in this position, tighten the intermediate pipe to converter clamp to a torque 52 Nm (38 ft. lbs.).

NOTE: After the intermediate pipe to catalytic converter clamp has been tightened, the intermediate pipe to underbody clearance at the first bend must fall within the 15-25 mm (5/8 in. - 1 in.) specification. This clearance measurement to the underbody should be taken at the point where the intermediate pipe transitions from a fore/aft orientation to a cross car orientation.

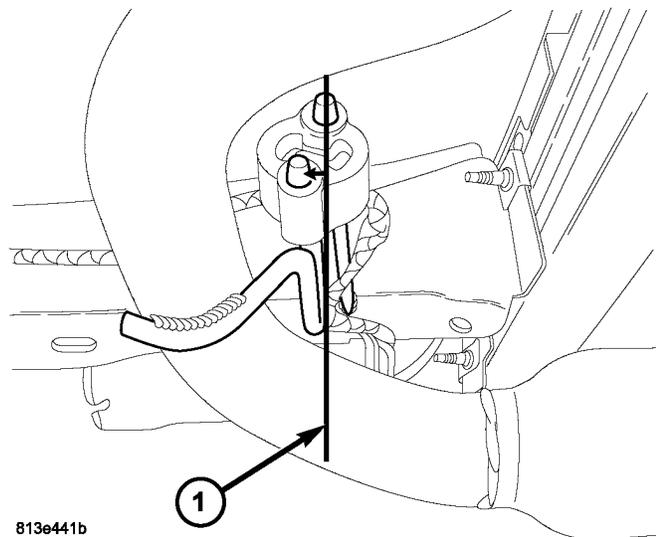
Fig. 2 RIGHT SIDE ISOLATOR ROTATIONAL ORIENTATION AT GREATER THAN 6 O'CLOCK POSITION

1 - EXHAUST TIP LOWER ISOLATOR HOLE/PIN PAST THE 6 O'CLOCK POSITION

5. Force the rearmost positioned exhaust tip forward so the rotational orientation of the exhaust tip isolator is greater than the 6 o'clock position, (Fig. 2).

6. With the rearmost exhaust tip held in this forward position, secure the Y-pipe to intermediate exhaust pipe clamp to a torque of 61 Nm (45 ft. lbs.).

NOTE: When finished exhaust tip isolators should have a rotational orientation which has the lower hole/pin is closer to the front of the vehicle than the top hole/pin. For an optimal fit condition, the right and left exhaust tip isolator should have a equal rotational orientation.
