NUMBER: 23-008-03

Right Side Cowl Water Leak

2003 PL Neon/SX 2.0

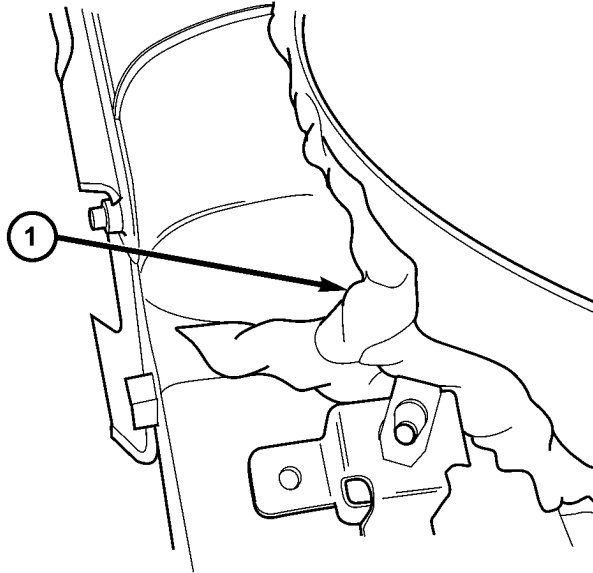
Fig. 1 RIGHT SIDE COWL BODY SEAMS

Water on the right front passenger floor.

1. Open Hood.
2. Remove the three screws holding the cowl grille/screen on the passenger side of the vehicle.
3. Partially remove hood to cowl seal, at the leading edge of cowl grille/screen.
4. Disengage grille/cowl screen anchor at center of cowl.
5. Rotate the right side cowl grille/screen out of the way of the cowl plenum being careful to not pull cowl grille/screen upper weatherstrip off.
6. Locate the large vertical and horizontal sealer beads near the right outboard cowl grille screen mounting screw attaching point (Fig. 1). The sealer beads are at the junction of the A-pillar, cowl plenum upper and cowl side panel. Apply Mopar Silicone Windshield & Glass Sealer, p/n 04467708, to the outer edge of all existing sealer beads.

1 - APPLY SEALER

- 7. Allow sealer to set up for 30 minutes. Water test right lower cowl area to verify repair. install passenger side cowl trim.
- 8. Reverse above procedure to install the cowl grille/screen.
