NUMBER: 08-014-04

Radio Intermittent Audio

This bulletin involves applying a label over slots in the radio top cover.

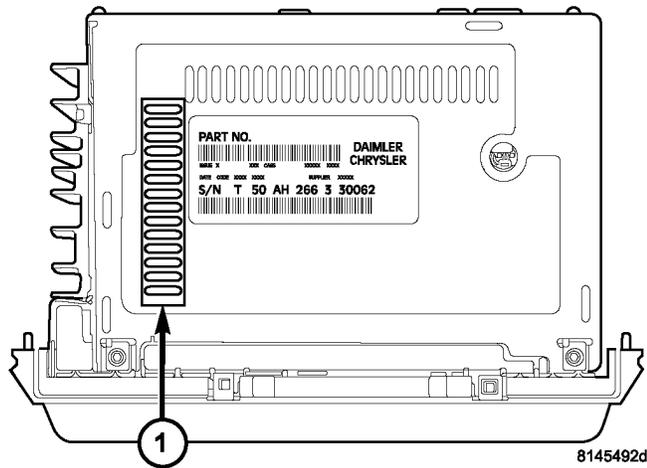
Fig. 1 COVER SLOTS

Audio drops out when vehicle is moved from cold to warm or humid environment. Condensation builds up across the audio amplifier circuitry causing amplifier to shut down. Typically, cycling ignition switch Off and back On will restore the audio output.

1 - COVER SLOTS COMPLETELY

NOTE: The two slots between the heat sink and the row of covered slots (1) also need to be completely covered and sealed with tape.

1. Remove radio from Instrument panel. Wiring connectors can remain connected.
2. Place 3M Vinyl Plastic Electrical Tape Super 33+ or Equivalent over the row of slots on the left hand side of the radio top cover, be sure to not cover information (barcode, etc.) on the radio's primary label (Fig. 1). Be sure the slots are covered completely and the tape is sealed all around the edges. Also cover and seal with tape, the two slots between the heat sink and the row of covered slots.
