# Technical Service Bulletin

**NUMBER:** 08-20-00

Horn Inoperative Or Sound Is Weak Or Muted

2000 (PL) Neon

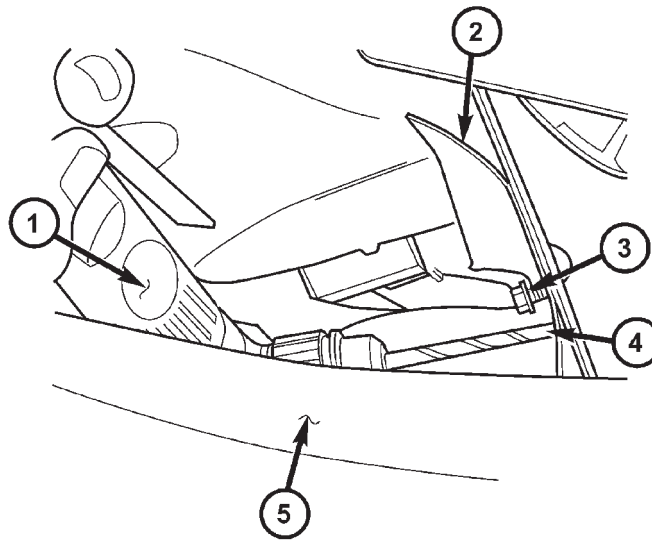
**FIGURE 1**

Due to horn orientation, water may enter the horn interior and cause damage. The horn may not work or the customer may report that the horn sounds quieter than before.

2. Remove the far right screw of the grill emblem where it attaches to the head lamp module housing.
3. Remove the two screws attaching the right headlamp module to the upper crossmember.
4. Pull the right headlamp module out and remove the connectors.
5. Remove the headlamp module from the vehicle.
6. Disconnect and remove the horn. Discard the horn.
7. Cut out the template provided in the kit.
8. Install the template and hold it in place by inserting the horn mounting bolt in its original position through the template. Mark the location of the new hole through the template.
9. Using a 6.5–mm (.25 in.) drill bit and an angle drill, drill a hole through the sheet metal at the point marked in step 8 (Figure 1).

10. Position and install the new horn using the original bolt hole. The new hole drilled in step 9 is for the anti–rotation tab on the new horn. The horn will now be approximately horizontal.
11. Install the headlamp module assembly and the grill emblem screw.
12. Install the battery negative cable.
