# Technical Service Bulletin

**NUMBER:** 23-51-99

Instrument Panel Top Cover Not Properly Seated at Outboard Edges

2000 (PL) Neon

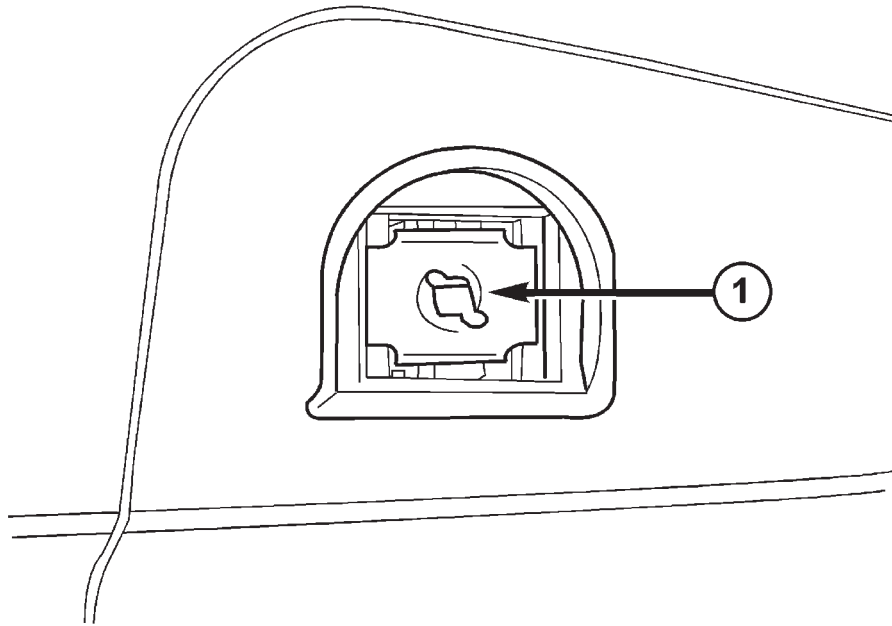
**FIGURE 1**

1-	RETAINER CLIP SHOWN IN PROPER POSITION - PASSENGER SIDE
----	---

1. Pull back the weather seal and use a trim stick (special tool #C-4755) to remove the A-pillar moldings.
2. There are two screws securing the top center of the instrument panel top cover at the edges of the defroster duct opening. Back the two screws part way out until the top cover can be removed. Remove the instrument panel top cover using the trim stick.
3. If a retainer clip is not already present, insert the retainer clip into the square hole in the instrument panel substrate on each end. Ensure that the clip is properly orientated with the small flanges horizontal (Figure 1).

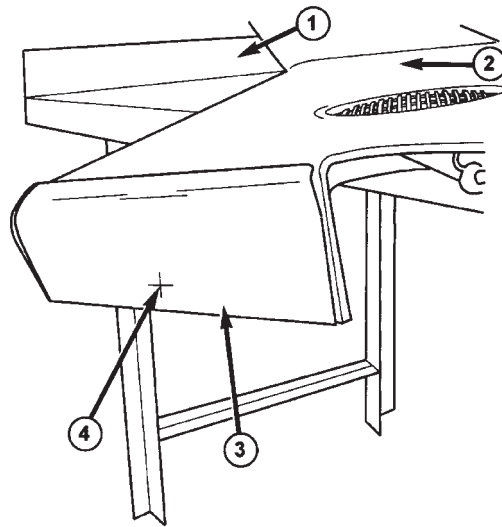
**FIGURE 2**

1-	WORK BENCH
2-	TOP COVER
3-	PASSENGER SIDE TEMPLATE SHOWN ATTACHED TO TOP COVER
4-	MARK CENTER OF X FOR PROPER DRILLING LOCATION

4. Cut out the templates supplied with the instruction sheet. The templates are labeled driver or passenger, ensure that the proper template is used or the hole will not be in the proper position. Tape the templates to the top cover (Figures 2 and 3).

5. With a pen or awl mark the center of the x of each template into the instrument panel top cover.
6. Remove the template and drill a 0.125 inch hole at the mark made in step 5.
7. Install the top cover and ensure that all clips are firmly seated. Install and torque the screws at the defroster vent to 20 in lbs.
8. Install the screws into the holes drilled in step 6 and torque to 20 in lbs. Figure 4 shows the passenger side screw properly installed.
9. Install the A-pillar moldings. Seat the weather seal around the A-pillar moldings.

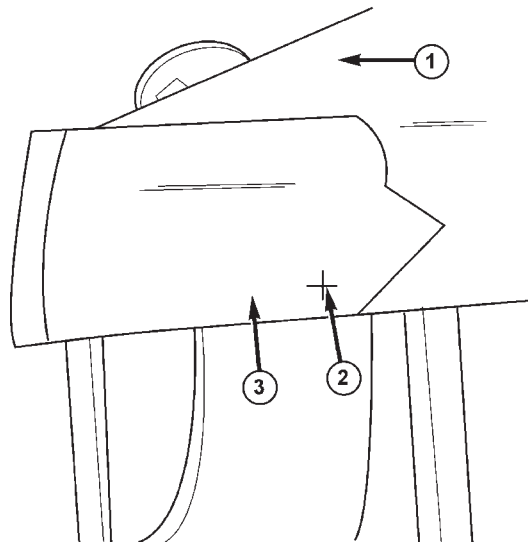
**FIGURE 3**

1-	TOP COVER
2-	MARK CENTER OF X FOR PROPER DRILLING LOCATION
3-	DRIVERS SIDE TEMPLATE SHOWN ATTACHED TO TOP COVER
