Technical Service Bulletin

NUMBER: 09-06-00

Changes To Timing Belt Tensioner Components

1999 – 2000 (GS) Chrysler Voyager (International Market)
1999 – 2000 (JA) Cirrus/Stratus/Breeze
1999 – 2000 (JX) Sebring Convertible
1999 – 2000 (PL) Neon

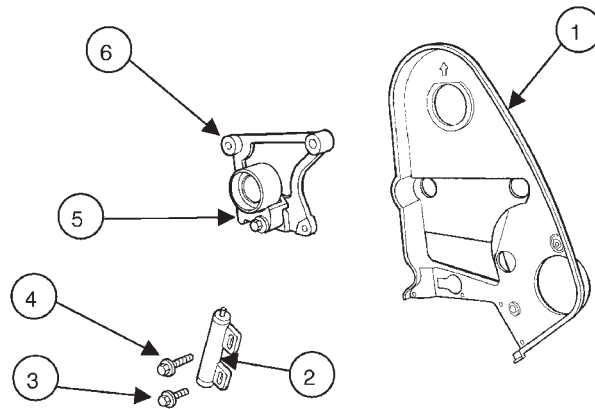
**FIGURE 1**

Each kit consists of a tensioner w/attaching bolts, tensioner pivot assembly, and rear timing belt cover (Figure 1).

3. Install a new rear cover and bracket assembly, from kit p/n 5018399AA 1999 Models w/o dowel locator or p/n 5018400AA 2000 Models w dowel locator (Figure 1). Torque all applicable bolts to the specifications listed in the service manual.

NOTE: THE BRACKET ASSEMBLY WITH THE SLEEVED LOCATOR HOLE SHOULD ONLY BE USED IF THE DISCARDED MECHANICAL TENSIONER HAD A SLEEVED LOCATOR HOLE.
