Technical Service Bulletin

NUMBER: 23-16-99

Decklid Does Not Open With First Cycle Of Key Fob Operation

2000 (PL) Neon

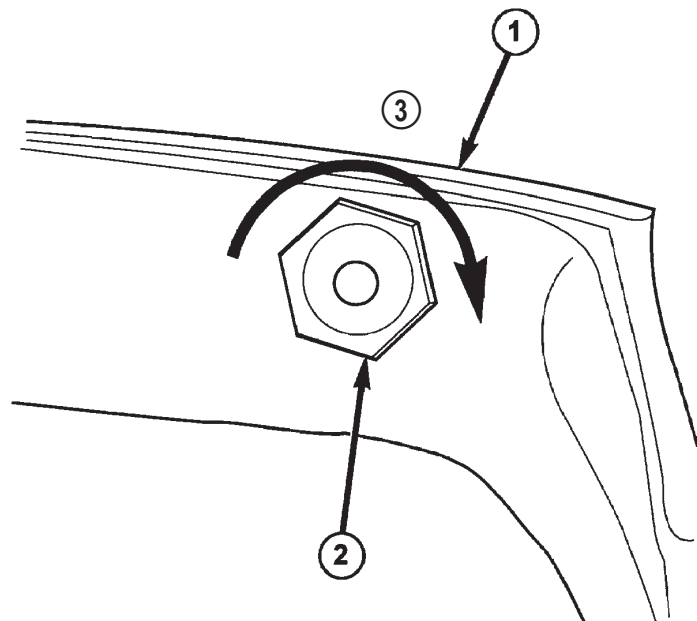
FIGURE 2

1 -	DECK LID
2 -	OVERSLAM BUMPER
3 -	TURN CLOCKWISE

1. Open the decklid, mark each bumper and turn each overslam bumper 1/4 turn clockwise (Figure 1 & 2).
2. Close the decklid and cycle the key fob decklid button.
3. Repeat the overslam adjustment procedure (steps 1 & 2) until one cycle of the key fob opens the decklid.

NOTE: THE OVER SLAM BUMPERS SHOULD NOT PROTRUDE MORE THAN 20MM FROM THE DECKLID INNER SHEET METAL.
