# Technical Service Bulletin

NUMBER: 08-21-00

Antenna Mast Installation

2000 - 2001 (PL) Neon

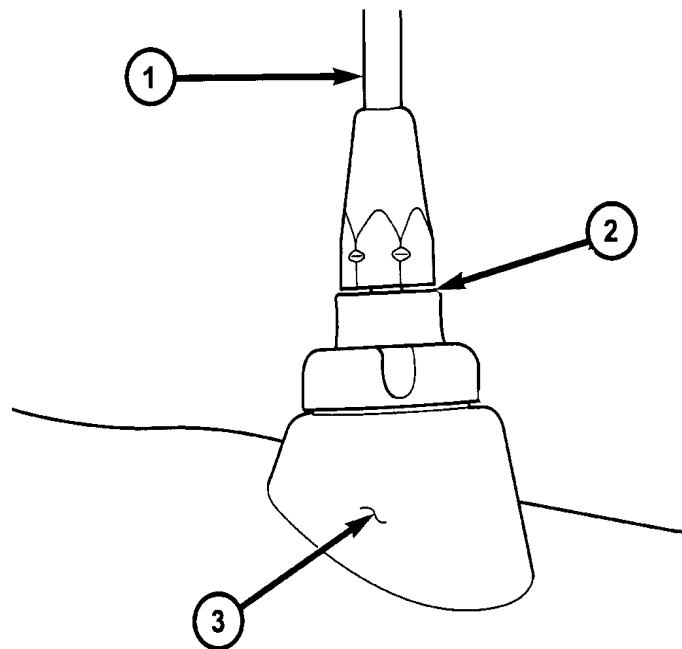
**FIGURE 1**

The Neon antenna mast is installed at the dealership during new vehicle preparation. Recently antenna masts have been coming into the material return center with mounting surfaces stripped. The Neon antenna should be torqued to 3.2 Nm (28 In. lbs.). With the antenna mast torqued to the proper amount (3.2 Nm (28 in. lbs)) there will be a slight gap between the mast and the base (Figure 1). The gap is there to ensure that there is no contact between the bottom of the antenna mast and the plastic surrounding the metal insert on the base. **Do not attempt to close the gap between the antenna mast and the base.**
