NUMBER: 19-002-04 REV. A

GROUP: Steering

Steering Column Click Sound

2000 - 2004 (PL) Neon

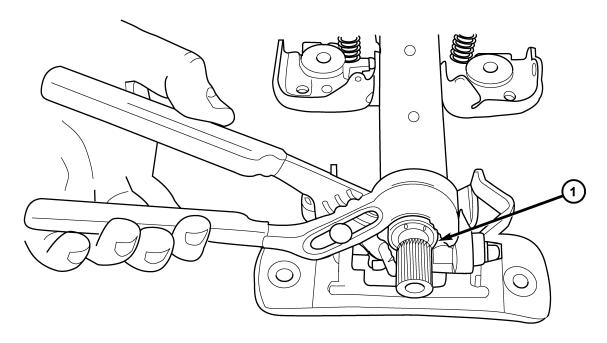
Fig. 1 SPRING RETAINER REMOVAL

1 - SQUEEZE THE OUTSIDE DIAMETER OF RETAINER TO REMOVE

- 15. Remove the two screws attaching the multifunction switch and separate the switch from the steering column.
- 16. Remove the steering column intermediate shaft from the steering column shaft. Install Remover/Installer, Special Tool 6831-A, through center of roll pin in intermediate shaft's universal joint and install knurled nut. While holding hex on end threaded rod, tighten the nut on threaded rod of Remover/Installer. This will pull the roll pin out of the intermediate shaft's universal joint. Using a screwdriver inserted between the shaft's universal joint and the steering column lower mounting bracket, gently pry intermediate shaft off steering column shaft.
- 17. Remove the spring retainer by squeezing the outside diameter with pliers and sliding it off the end of the steering column shaft, refer to (Fig. 1).

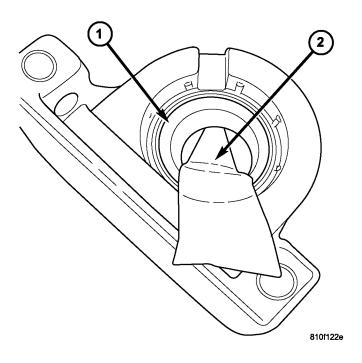
Fig. 2 CHECK THAT BEARING IS FULLY SEATED

- 1 BEARING
- 2 0.005 IN. FEELER GAUGE
- 21. Install the revised steering column shaft p/n 05057229AA, revised wedge, p/n 04690570, and **revised preload spring, p/n 05057088AA**.
- 22. Thread the steering wheel bolt into the steering column shaft.
- 23. Stand the column assembly on the head of the steering wheel bolt, insure the surface is flat. Refer to (Fig. 3).

- 18. Remove the spring, wedge and steering column shaft.
- 19. Inspect the upper and lower steering column bearings, if damaged replace them/it as necessary, p/n 04690507AB upper bearing, p/n 04690344AB lower bearing (with notch).
- 20. Stand the steering column on end so the outer race of the upper bearing is supported on a 1 1/16 in. socket. Using a 7/8" deep well socket or other suitable tool placed against the lower bearing outer race tap the bearing downward several times with a brass hammer until the bearing is fully seated. Use a 0.005" feeler gauge to make sure no clearance exists between the lower casting and the outer race of the lower bearing. Refer to (Fig. 2)

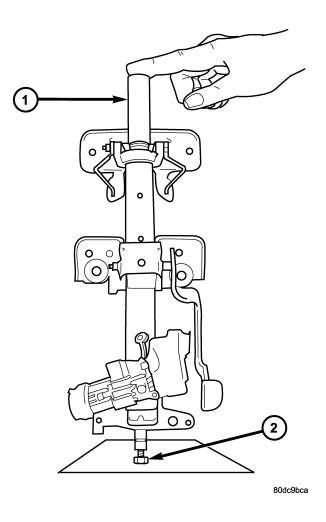
Fig. 3 STAND STEERING COLUMN ON END

- 1 7/8 IN. DEEP WELL SOCKET
- 2 INSURE SURFACE IS FLAT
- 24. Install a new retainer, p/n 04664130, onto the steering column shaft by using a 7/8" deep well socket and small hammer to tap the retainer into place so the installed distance between the lower housing and the outside face of the retainer is 12-14 mm (15/32-17/32 in.). If the retainer is installed to distance less than 12 mm (15/32 in.) remove the retainer and install a new retainer, repeat as necessary until the installed distance is 12-14 mm (15/32-17/32 in.). Refer to (Fig. 4).

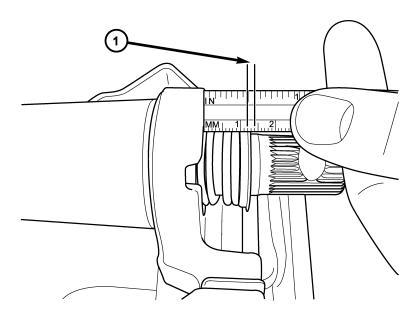
Fig. 4 INSTALLATION DISTANCE

NOTE: If the installed dimension is less than 12mm a binding condition may result. If the installed dimension is greater than 14mm a loose condition may result.

1 - INSTALLED DISTANCE BETWEEN THE LOWER HOUSING AND THE OUTSIDE FACE OF THE RETAINER MUST BE 12-14 mm (15/32-17/32 in.)
