NUMBER: 09-007-04

GROUP: Engine

Irregular Engine Snapping Sound

This bulletin involves chamfering the bore radius on cam bearing caps L2 through L5 and R2 through R5.

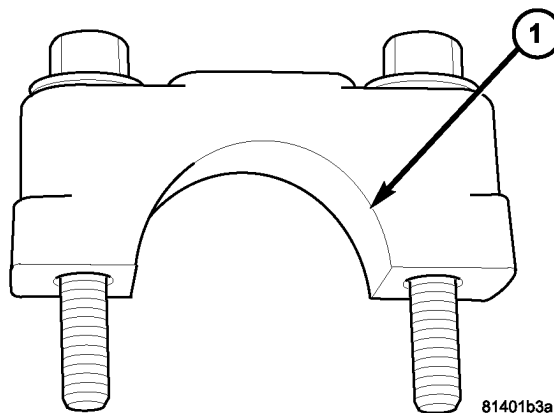
Fig. 2 CAMSHAFT BEARING CAP

1 - CAM BEARING CAP RADIUS

3. Lightly chamfer the two bore radius edges with a small hand file, creating a 45° chamfer 1.0 to 1.5 mm in width along the edge of each bore radius (Fig. 2).

CAUTION: Be careful not to scratch bore surface of cam bearing cap. Chamfer both bore radius.
