NUMBER: 11-001-05

Exhaust Tip Alignment

2003 - **2005** (PL) Neon SRT4

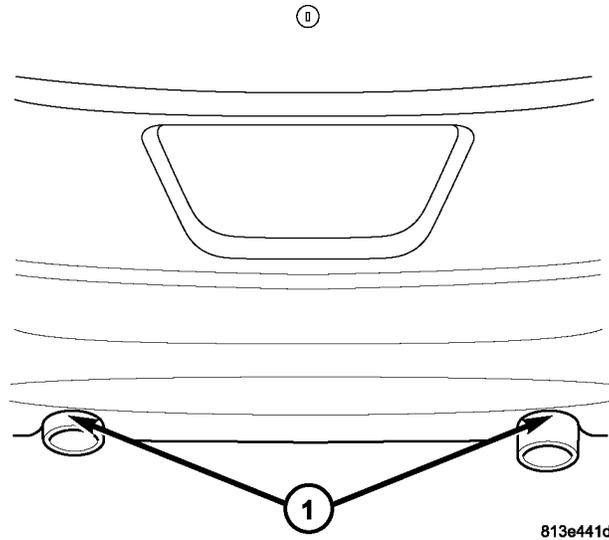
Fig. 1 EXHAUST TIP MISALIGNMENT

Dual exhaust tips are not in equal fore/aft alignment.

Visually inspect vehicle for exhaust tip alignment issues. If exhaust tips are misaligned in the fore/aft dimension relative to each other as shown in (Fig. 1), perform the Repair Procedure.

1 - RIGHT SIDE SHOWN PROTUDING MORE THAN LEFT SIDE - SHOULD BE EQUAL

1. Loosen intermediate exhaust pipe to catalytic converter clamp.
2. Loosen Y-pipe to exhaust intermediate pipe clamp.

3. Raise the intermediate pipe to the point where the first bend from the catalytic converter has a clearance of 15-25 mm (5/8 in. - 1 in.) from the underbody.
4. With the intermediate exhaust pipe held in this position, tighten the intermediate pipe to converter clamp to a torque 52 Nm (38 ft. lbs.).

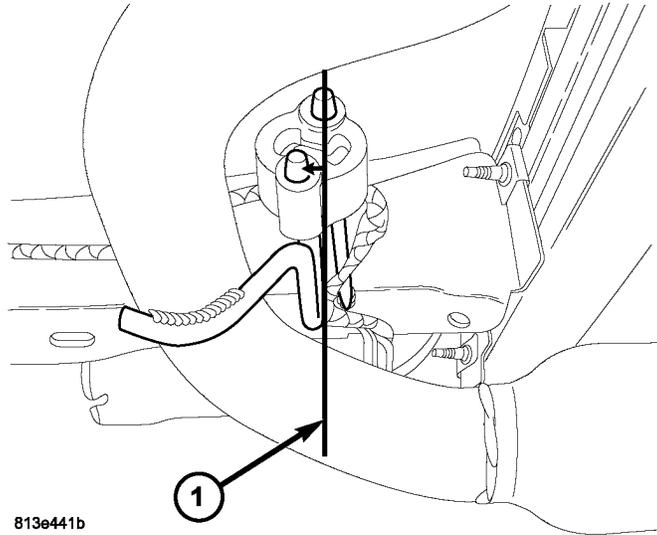
Fig. 2 RIGHT SIDE ISOLATOR ROTATIONAL ORIENTATION AT GREATER THAN 6 O'CLOCK POSITION

1 - EXHAUST TIP LOWER ISOLATOR HOLE/PIN PAST THE 6 O'CLOCK POSITION

5. Force the rearmost positioned exhaust tip forward so the rotational orientation of the exhaust tip isolator is greater than the 6 o'clock position, (Fig. 2).

- 6. With the rearmost exhaust tip held in this forward position, secure the Y-pipe to intermediate exhaust pipe clamp to a torque of 61 Nm (45 ft. lbs.).

NOTE: When finished exhaust tip isolators should have a rotational orientation which has the lower hole/pin is closer to the front of the vehicle than the top hole/pin. For an optimal fit condition, the right and left exhaust tip isolator should have a equal rotational orientation.
