International Technical Service Bulletin

NUMBER: I26-807-03

Owner Manual Addendum - Headlamp Bulb Replacement

2004 (PL) Neon

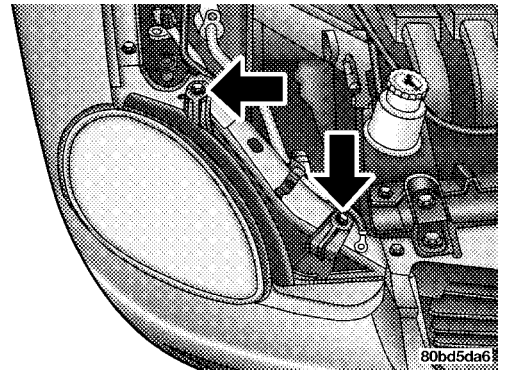
1. Remove two screws from the headlamp module and pull module from the vehicle.

NOTE: The headlamp module is located to the fender by a molded pin. Pull the outboard side of the headlamp straight out until the molded pin clears the fender, then slide the headlamp out from behind the bumper fascia and grille.

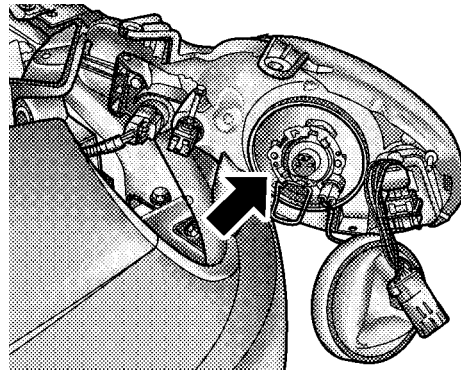
2. Disconnect electrical connector and remove the rubber boot seal.

3. Remove retaining ring and replace bulb.

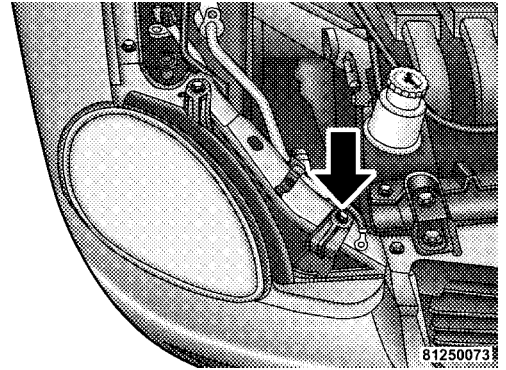
During installation, be sure when tightening the inboard screw, to only tighten until the rubber grommet on the screw starts to compress against the headlamp module housing.
