NUMBER: 18-037-05

GROUP: Vehicle Performance

Flash Programming Failure Recovery Using DRBIII®

This Bulletin provides guidelines, to minimize flash reprogramming problems, and information on recovery procedures for failed flash attempts.

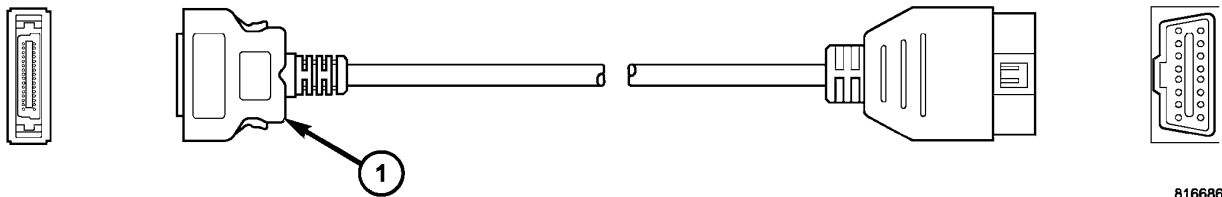
Fig. 1 CH7000A CABLE

The cable modification enhances the DRBIII® communication capabilities when dealing with the flash requirements of certain controllers/ECUs affected in part by the recent changes in DLC connector configurations.

The new cable is required for ALL flash reprogramming sessions, and can be used wherever the previous CH7000/7001 cables were used. To place additional cable orders for all your DRBIII®s, call 1-800-223-5623.

1 - DRBIII® CONNECTOR (RED)

While not recommended for flash reprogramming usage, if you require a longer cable, there is also a 12-foot cable released under p/n CH7001A
