NUMBER: 18-037-05

GROUP: Vehicle Performance

Flash Programming Failure Recovery Using DRBIII®

This Bulletin provides guidelines, to minimize flash reprogramming problems, and information on recovery procedures for failed flash attempts.

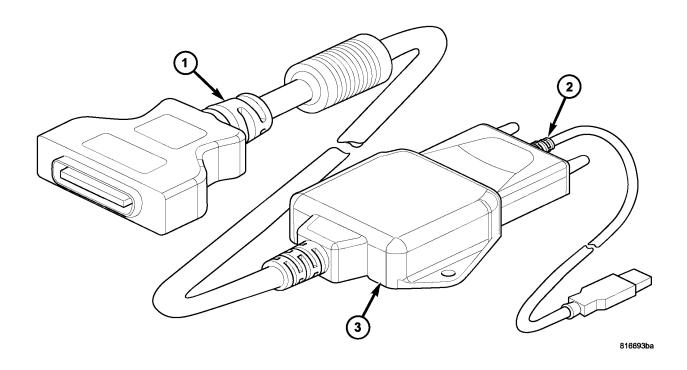
Fig. 2 CH2002 ASSEMBLY

- 1. Turn-on the power to the DRBIII® unit.
- 2. Select option 2 "Connect to TechCONNECT" and press Enter.
- 3. Attach the **male mini D-shell amphenol GPIB connector** of the **new** DRBIII® cable (part number CH7035B) to the DRBIII® unit.
- 4. Insure that the **larger female D-shell amphenol GPIB connector** of the **new** DRBIII® cable is properly attached to the **male D-shell amphenol GPIB connector** on the **GPIB-USB-B** protocol converter, (part number CHGPIB-B).
- 5. Attach the **USB cable** from the **GPIB-USB-B** protocol converter to one of the USB ports on the rear panel of the client CPU.
- 6. When the cable is attached to the USB port of the CPU for the first time, Windows 2000 will detect the device and install software for it. Please wait for 25-30 seconds to complete the installation.

- 1 CH7035B
- 2 CHGPIB-B
- 3 CH7036
