Technical Service Bulletin

NUMBER: 22-005-01

Wheel Cover Rattle - 15" Steel Wheels

2000 - 2001 (PL) Neon

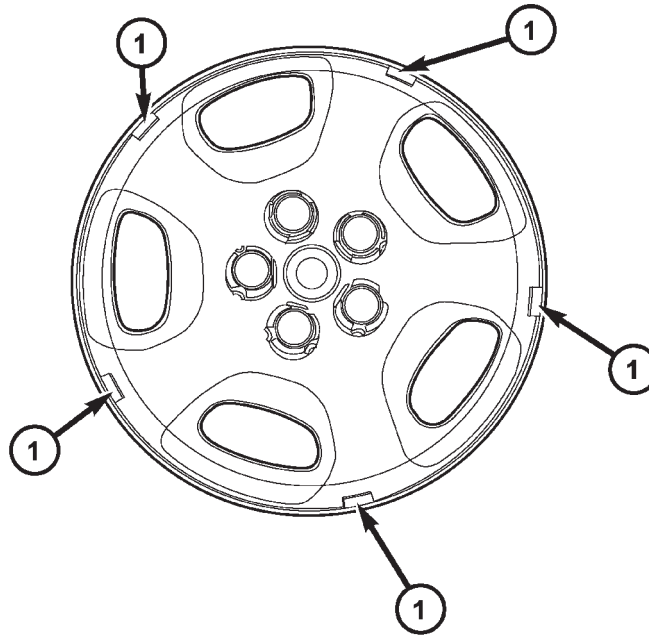
FIGURE 1 - WHEEL COVER

Rattle noise coming from the wheel cover over bumps.

1-	FOAM PADS
----	-----------

1. Clean the inside surface of the wheel cover where the foam pad will be installed using the Mopar Brake Parts Cleaner.
2. Wipe the cleaner off and allow the wheel cover to dry thoroughly.
3. Remove the backing paper from a foam pad and apply to in the center of one wheel spoke. Repeat the process until all five foam pads have been installed. (Figure 1)
4. Repeat the procedure for the remaining three wheel covers.
5. Install the four wheel covers onto the vehicle and torque nuts to 25 in.lbs.
