NUMBER: 08-010-03

Seat Belt Cinch Bar Service

2001 - 2003	(AB)	Ram Van/Wagon (Front Passenger Seat Belt Only)
1994	(BR)	Ram Pickup
1996- 2002	(BR/BE)	Ram Pickup
2001 - 2003	(DN)	Durango (Front Passenger Seat Belt Only)
1995 - 2000	(JA)	Breeze/Cirrus/Stratus
2001 - 2004	(JR)	Sebring Convertible/Sebring Sedan/Stratus Sedan
1996 - 2000	(JX)	Sebring Convertible
1995 - 2003	(PL)	Neon/SX 2.0
2001 - 2003	(PT)	PT Cruiser

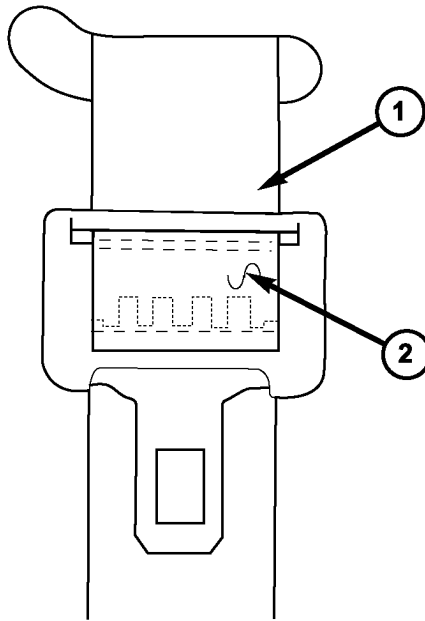
Fig. 1 SEAT BELT CINCH BAR

Any time the seat belt cinch bar (Fig. 1) is loose, missing or damaged it is no longer necessary to replace the seat belt assembly. Cinch bar repair kits are now available for the vehicles listed. If any component of the seat belt assembly has been damaged due to collision, the entire assembly must be replaced.

1 - Seat Belt

2 - Cinch Bar Mechanism

NOTE: THE CINCH BAR, CINCH BAR COVER OR ANY OTHER COMPONENT OF THE SEAT BELT ASSEMBLY MUST NEVER BE PAINTED.

NOTE: INSTALLATION INSTRUCTIONS ARE INCLUDED WITH EACH KIT.
